Manhole Inspection Summary

Manhole # S17EE2017MH

Insp Date: **10/25/06 9:56 PM**

Location Address: **1700 KELLY AVE**

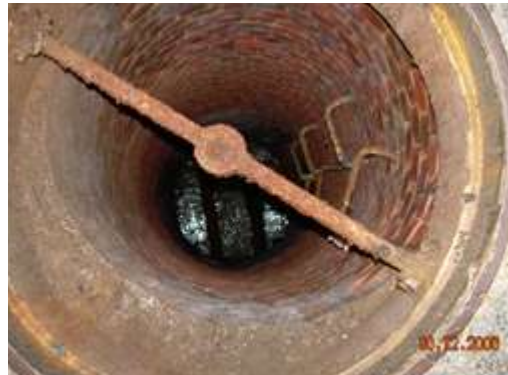
Top View

Fram leaks. Frame offset. Corbel and Barrel infiltration. Evidence of surcharge - Bench debris. Corroded steps.

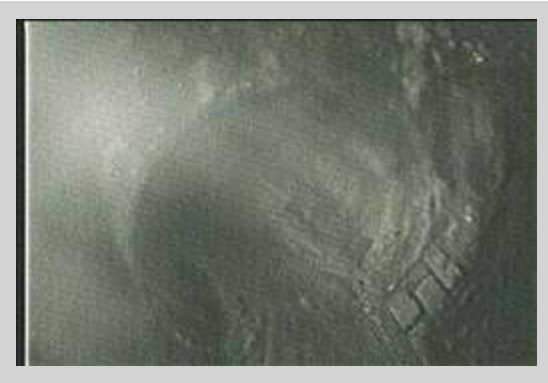
24 in. Circular Gravity Sewer Pipe Out @ 12 O'Clock

Invert Depth: **20.43** (ft.) Flow Characteristics: **Fast**

Infiltration: **None** Pipe Seal Cond: **Unknown**
